TECHNICAL INSPECTION REPORT

⑥ OPERATION CROSSROADS.

U.S.S. ARKANSAS (BB33).

TEST ABLE.

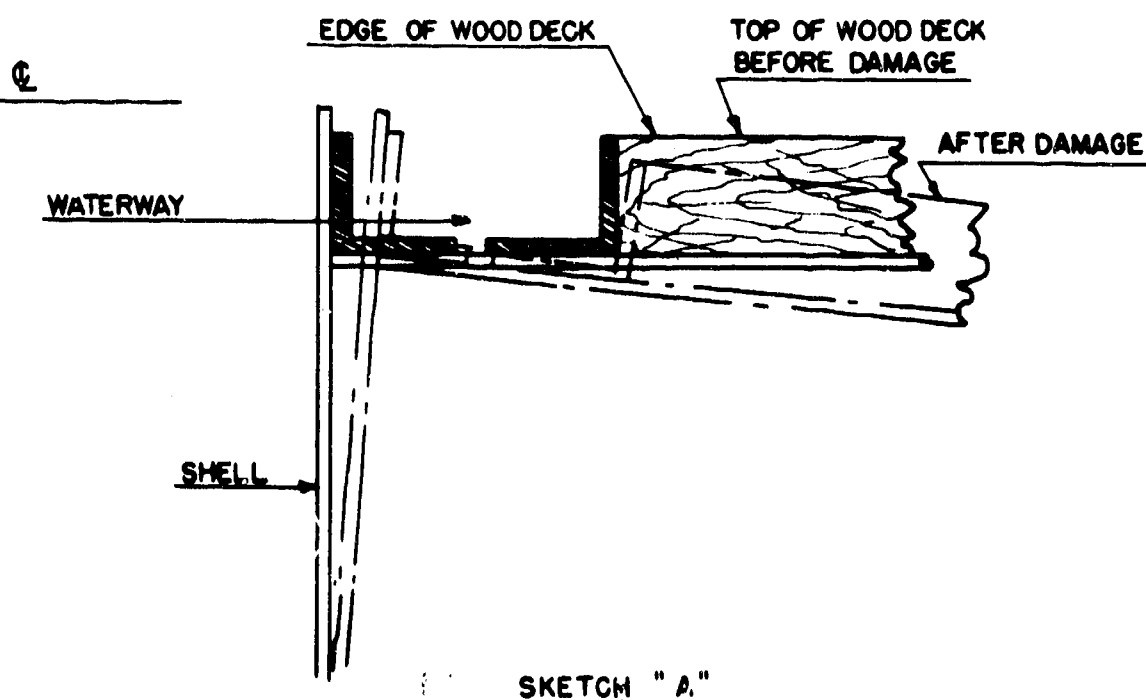
DEFLECTIONS WERE MEASURED FROM STRINGS STRETCHED LONGITUDINALLY ON THE DECK. ENDS OF THE STRING WERE EXTENDED TO PORTIONS OF THE DECK REASONABLY FREE OF ANY DEFLECTION. IN THIS RESPECT, IT WAS NECESSARY TO ASSUME THAT THE EDGE OF THE WOOD DECK ALONG THE SIDES WAS LEVEL WHICH IS UNTRUE. DISHING OF THE DECK CAUSED THIS EDGE TO PULL INBOARD AND DOWN. SEE SKETCH "A".
